CONSTRUCTION GENERAL PERMIT SITE INSPECTION REPORT LEVEL 2 (COMPREHENSIVE)

Project Name:	Louisa Solar (Virginia Electric & Power Co).	Permit Number:	VAR10I424
Project Address:	495 Chalklevel Rd. Louisa, Virginia	County/City:	Louisa
Project Operator:	See comments section.	Operator Telephone:	See comments section
Project Contact:	Robert B. Smith, Project Manager	Contact Telephone:	804-273-3725
Contact E-Mail:	Rob.smith@dom.com	Qualified Personnel (QP):	James Dorton/Regina Chavis
Inspector:	Tadric Page & Kendall Allen	Weather (Wet/Dry/Rain):	Intermittent rain, cloudy, ~75 F
Disturbed Acreage:	~174 acres	Inspection Date & Time:	September 27, 2016 @10:15 a.m.

CONSTRUCTION GENERAL PERMIT SITE INSPECTION REPORT REQUEST FOR CORRECTIVE ACTION

CONSTRUCTION GENERAL PERMIT SITE INSPECTION PHOTO LOG

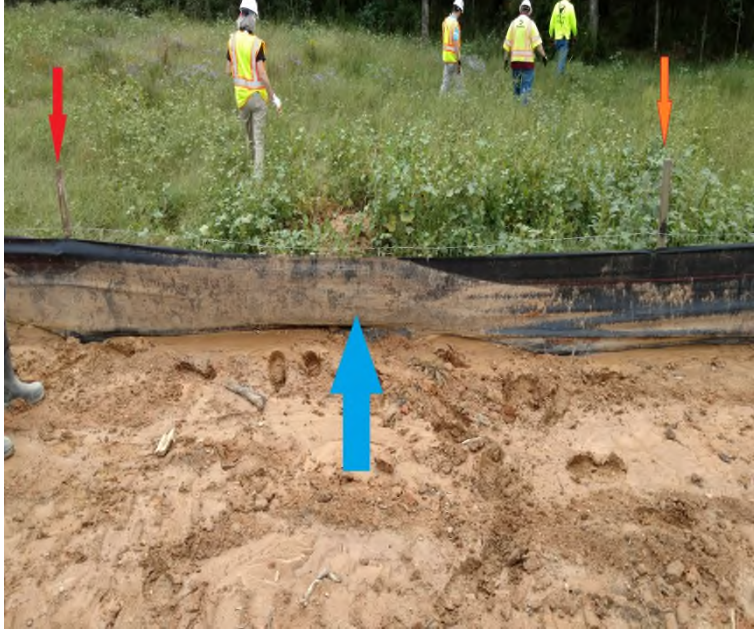
1. **Silt Fence (Fig 1 & 2):** DEQ observed a section of silt fence that was not properly staked in accordance with standard and specification 3.05. It appeared that the staking of this section of silt fence was more than six feet in length. **Note:** DEQ observed what appeared to be a sediment discharge in the area the silt fence appeared to be intended to protect. **Note:** Site staff corrected this deficiency before DEQ departed the site.

Fig. 1 showing missing stake in silt fence.

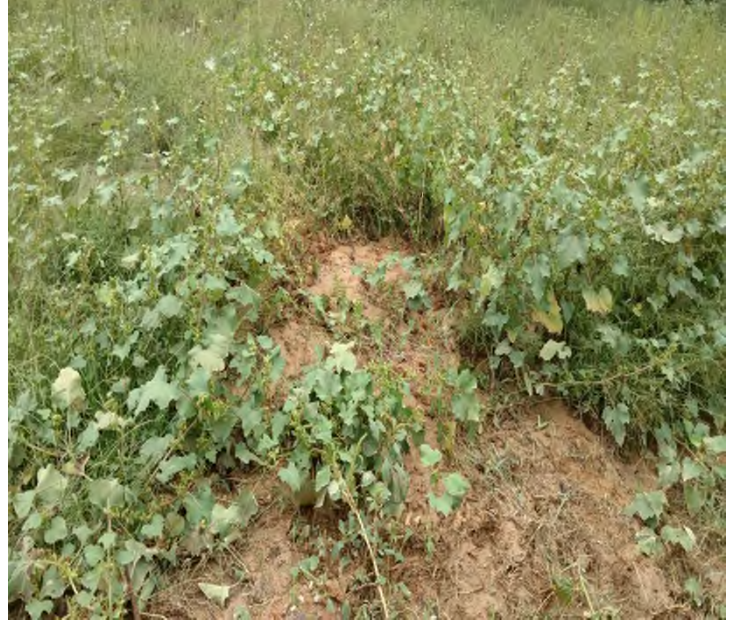
Fig. 2 showing sediment release behind silt fence shown in Fig 1.

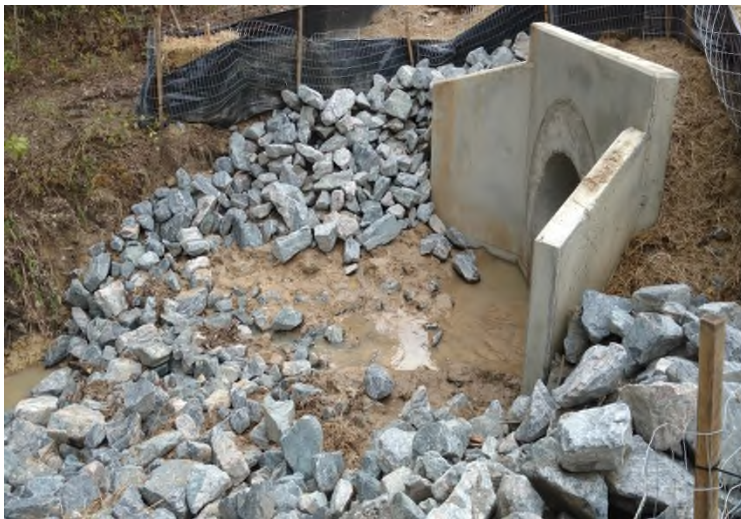
2. **Inlet/outlet protection (Fig 3):** The inlets & outlets of both culvert pipes associated with the stream-crossings appeared inadequately protected. The inlets/outlets appeared to contain sediment that covered some of the existing riprap, and the visible riprap did not appear installed and/or positioned adequately to protect the outlet and inlets. **Note:** Post the inspection, DEQ confirmed with Ms. Camille Cook, Dominion Environmental Services, that cleanout of these areas can be conducted in accordance with the applicable Nationwide Permit issued by the Core of Engineers (Nation 51, according to Ms. Cook).

Fig. 3 showing inadequate outlet protection at stream-crossing.

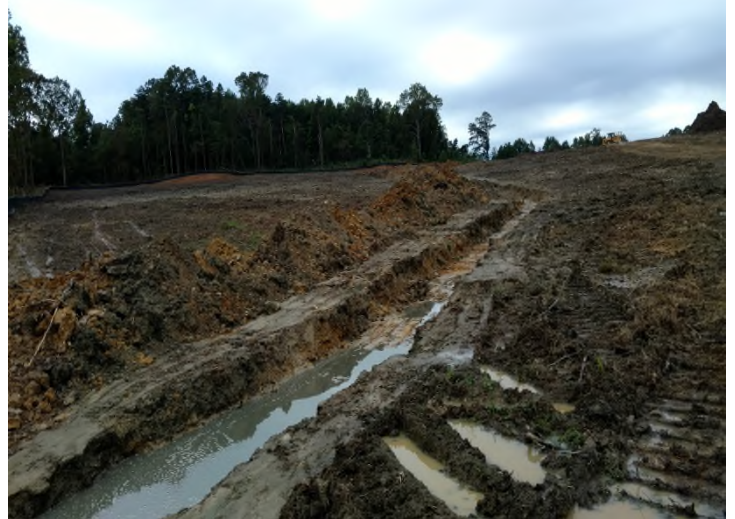
40	9VAC25-840-40.11	1	<p>Observation: At the time of inspection, DEQ observed a Stormwater conveyance channel that appeared to be unlined and unprotected. The channel discharges into a rock-pile. Beyond the rock pile, water, sediment and debris collects behind a silt fence that is located approximately 10 feet behind the rock pile.</p> <p>Recommended Corrective Action: 9VAC25-840-40.11 requires that "before newly constructed stormwater conveyance channels or pipes are made operational, adequate outlet protection and any required temporary or permanent channel lining shall be installed in both the conveyance channel and receiving channel".</p>
47	9VAC25-840-19(a-n)	1	<p>Observation: At the time of inspection, DEQ observed areas at the site where sediment appeared to have discharged beyond the silt fences installed.</p> <p>Recommended Corrective Action: 9VAC25-840-19 requires that "properties and waterways downstream from development sites shall be protected from sediment deposition, erosion and damage due to increases in volume, velocity and peak flow rate of stormwater runoff for the stated frequency storm of 24-hour duration in accordance with the following standards and criteria. Stream restoration and relocation projects that incorporate natural channel design concepts are not man-made channels and shall be exempt from any flow rate capacity and velocity requirements for natural or man-made channels". See sections a-n of the minimum standard for further details.</p>

3. As noted in checklist item #40, DEQ observed a stormwater conveyance channel constructed at the site that discharged to a rock structure and silt fence. Based on DEQ's observations, it appeared that the conveyance channel was not adequately protected and the area subject to discharges did not appear to be constructed correctly. The inspection contacts indicated that they planned to construct a sediment trap in this area, in accordance with standard and specification 3.13 (See Fig 4 & 5).

Fig. 4 showing unprotected Stormwater conveyance channel.

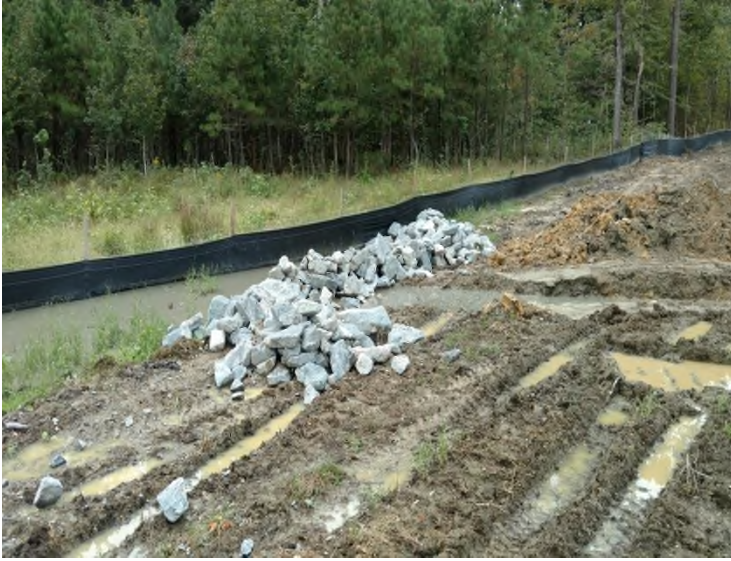
Fig. 5 showing sediment trapping area at end of conveyance channel (Fig 4). The sediment trapping area should be constructed in accordance with standard & specification 3.13.

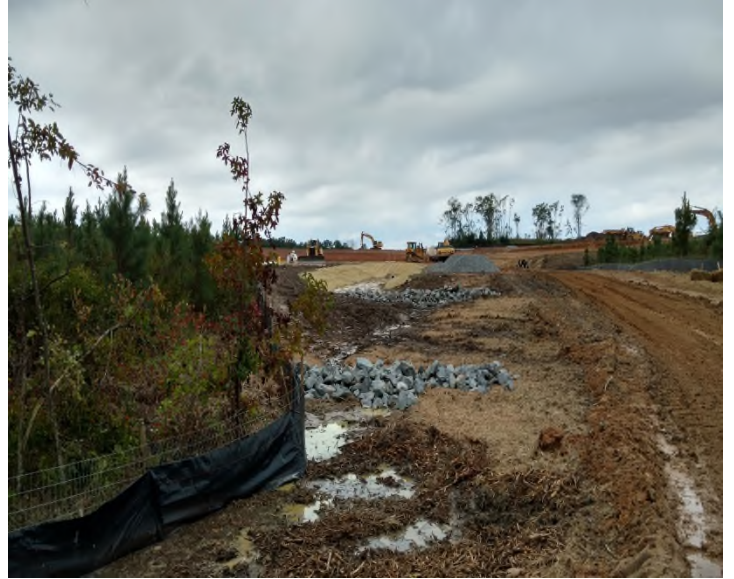
Checklist #	Regulatory Citation/Legal requirement ¹	Occurrence	Observation/Recommended Corrective Action
37	9VAC25-840-40.8	1	<p>Observation: At the time of inspection, DEQ observed that runoff from the sloped area (swale) between the Stormwater pond #8 and the stream crossing #1 is not being contained adequately.</p> <p>Recommended Corrective Action: 9VAC25-840-40.8 requires that "concentrated runoff shall not flow down cut or fill slopes unless contained within an adequate temporary or permanent channel, flume or slope drain structure".</p>

4. As noted in checklist item #37, DEQ observed a sloped area (swale) in between the stormwater pond #8 and the stream-crossing #1 (designations identified by site staff). The outlet (downhill area) of the stormwater pond appeared unprotected. It appeared that water discharges over the berm of the basin when full. The downstream area beyond the discharge, leads to the corner of the stream-crossing #1. A super silt fence is installed to help protect the stream and adjacent areas from discharges from the subject basin. At the time of inspection, DEQ observed a large volume of accumulated standing water and debris at the super silt fence. DEQ observed rock piles and wood mulch installed above the stream-crossing area that appeared to be intended to control the flow of water to the stream-crossing area. The installed rocks and mulch did not appear adequate to protect the subject area. **Note:** Dominion previously reported that the creek associated with the crossing, and the adjacent areas, have been subject to sediment discharges from silt fence failures, etc. (see Fig 6, 7 & 8).

Fig. 6 showing upslope area between stream-crossing #1 and Stormwater pond #8.

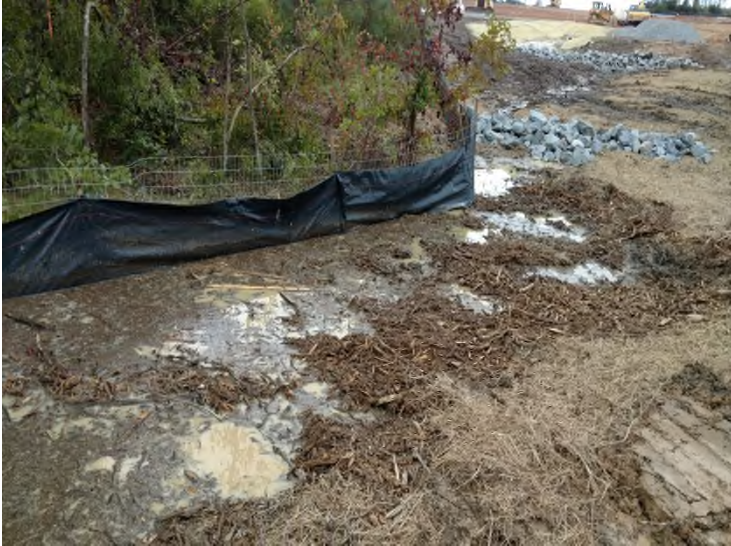
Fig. 7 showing sediment laden water and debris in between basin #8 and stream-crossing #1.

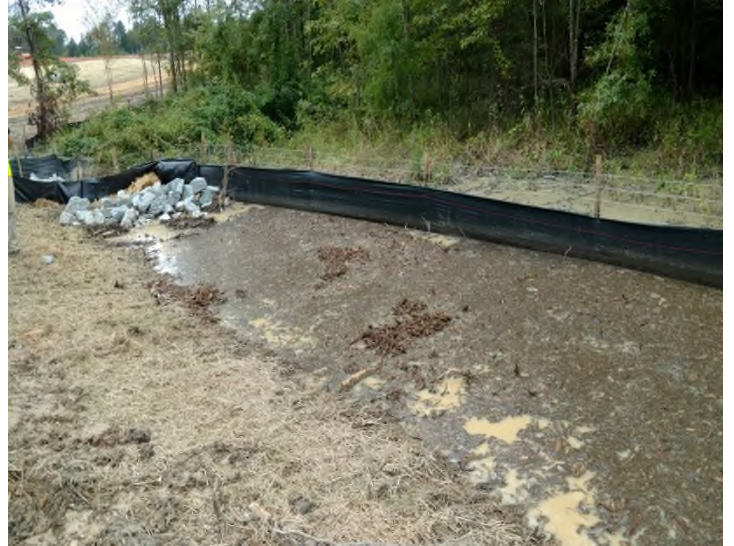
Fig. 8 showing upslope area to stream (note sediment laden water beyond silt fence).
